UNITED STATES ENVIRONMENTAL PROTECTION AGENCY

Subject: September 1, 2017 Clean Water Act Compliance Inspection

CWA COMPLIANCE EVALUATION INSPECTION REPORT
U.S. ENVIRONMENTAL PROTECTION AGENCY, REGION 5

Date of Inspection: September 1, 2017

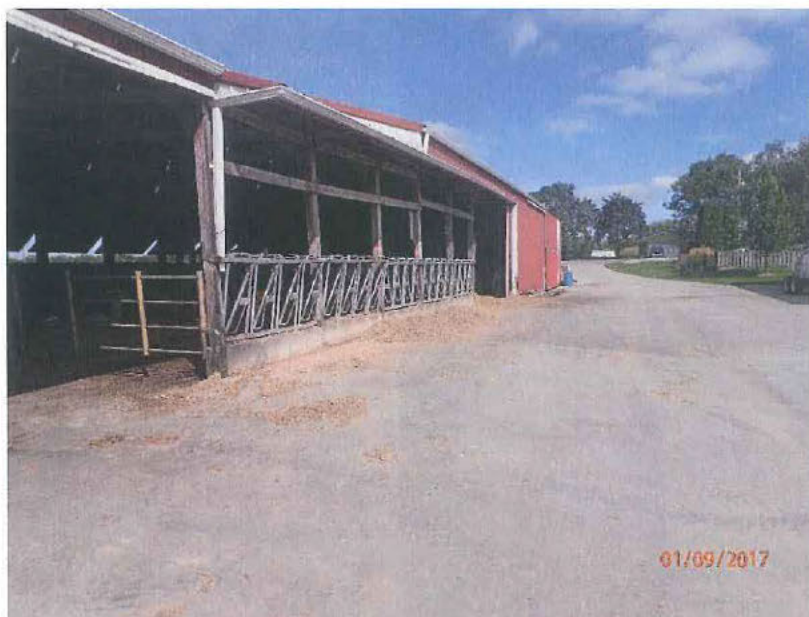
6: P9012514

Description: Machine Shed #2 and Close Up Cow Barn #1. Feed is open to precipitation but is mostly kept scraped under small overhang.

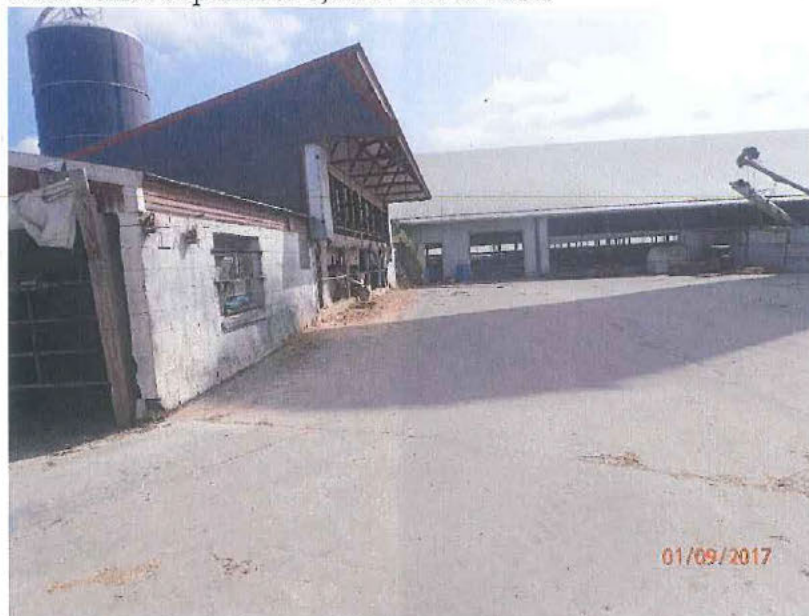
7: P9012515

Feed and bedding also could be transported with precipitation from the south side of the Close Up Cow Barn #2 to the storm water gutter.

Description: Close Up Cow Barn #2 on left and Freestall Barn #2 in back. Feed in front of Close Up Cow Barn #2 is kept scraped so it is under the overhang. Storm water would flow to the grate and gutter to the west.

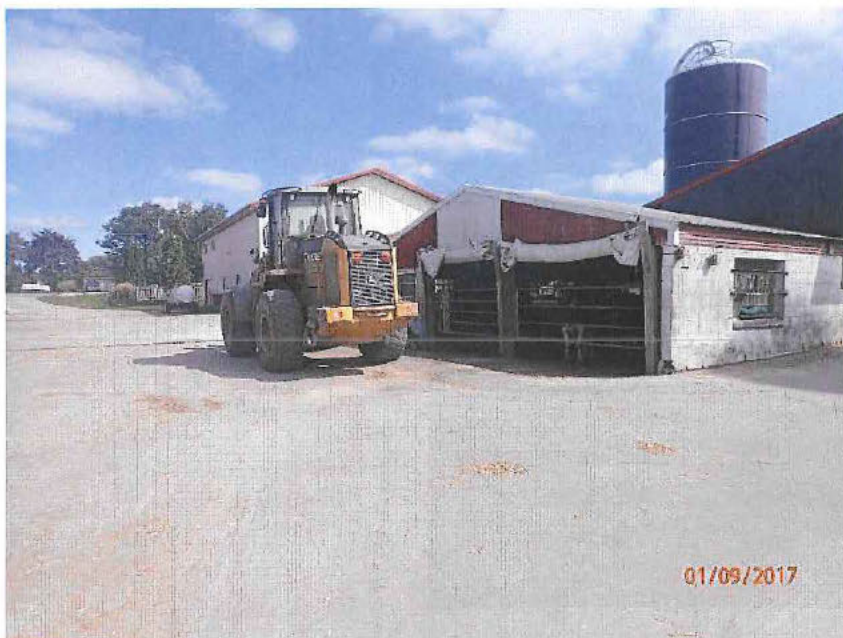
9: P9012517

Description: West side of Close Up Cow Barn #2. Note the grate for the storm water gutter in the pavement to the north of the tractor.

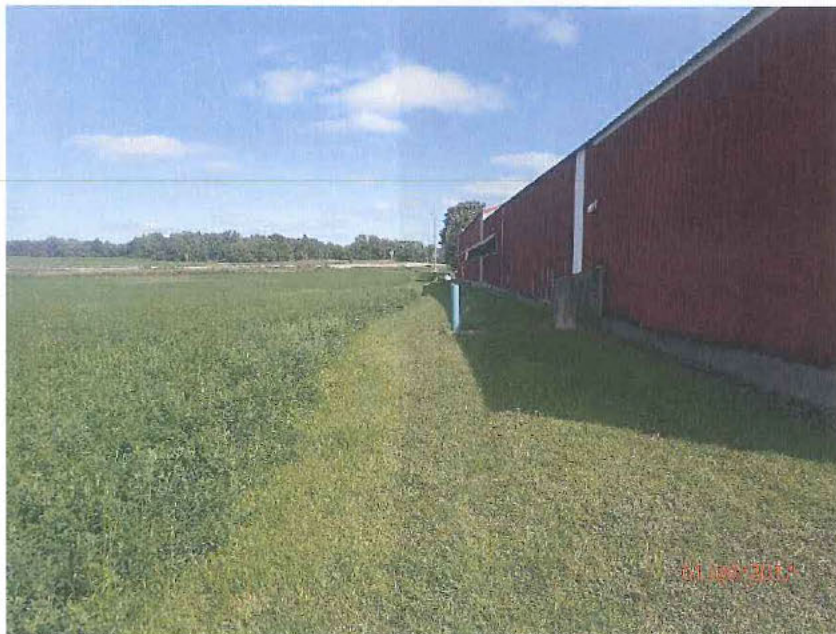
11: P9012519

Description: The ditch on the west side of the facility has been piped underground. Breather pipe indicates location of the buried PVC pipe.

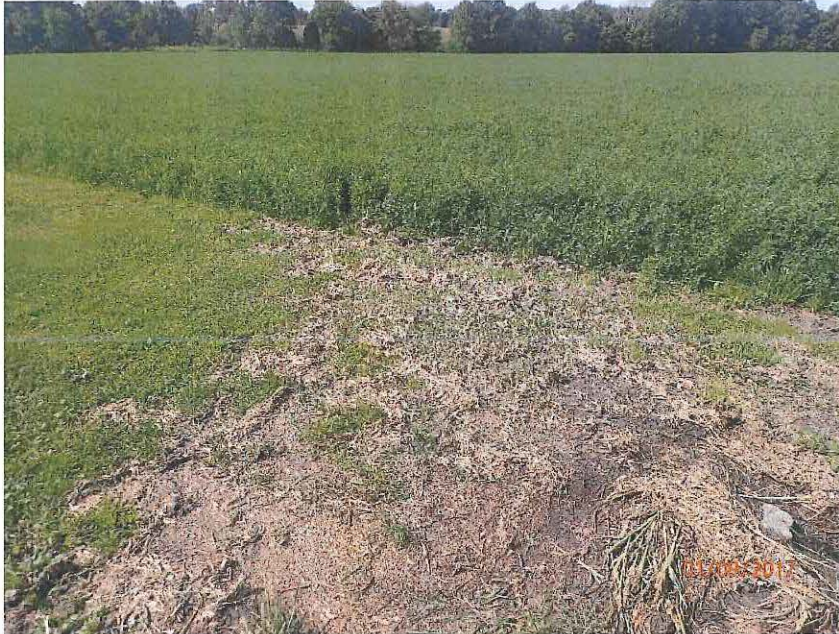
13: P9012521

Description: After outletting at the surface, flow from the pipe goes overland to the west then to the south.

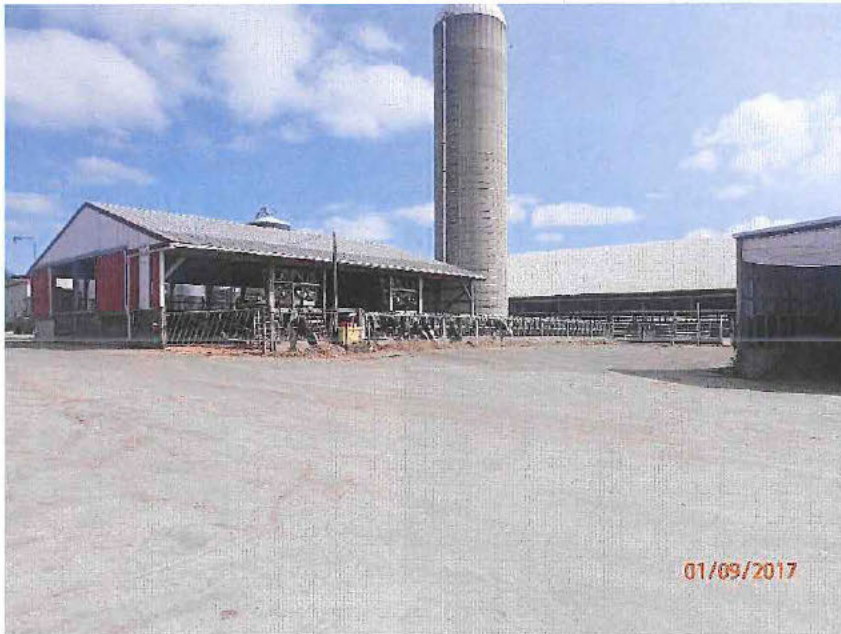
16: P9012524

Description: South side of Dry Cow Barn. Any process wastewater from this side of the barn would flow to the south.

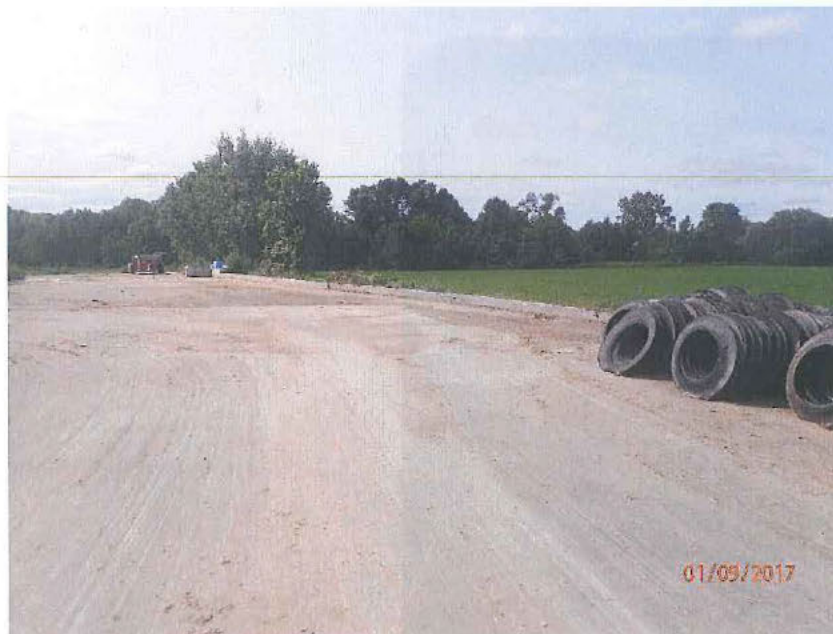
18: P9012526

Description: A two foot retaining wall was built on the west side of the Feed Storage Pad to keep the flow of process wastewater from entering the ditch on the west side of the facility.

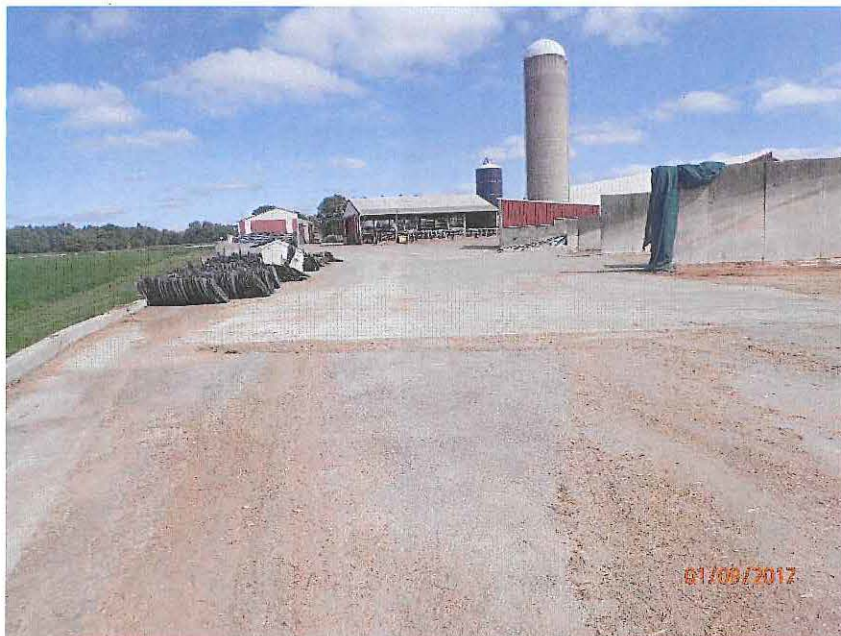
19: P9012527

Description: Retaining wall on west side of Feed Storage Pad prevents the flow of process wastewater to the ditch on the west side of the facility.

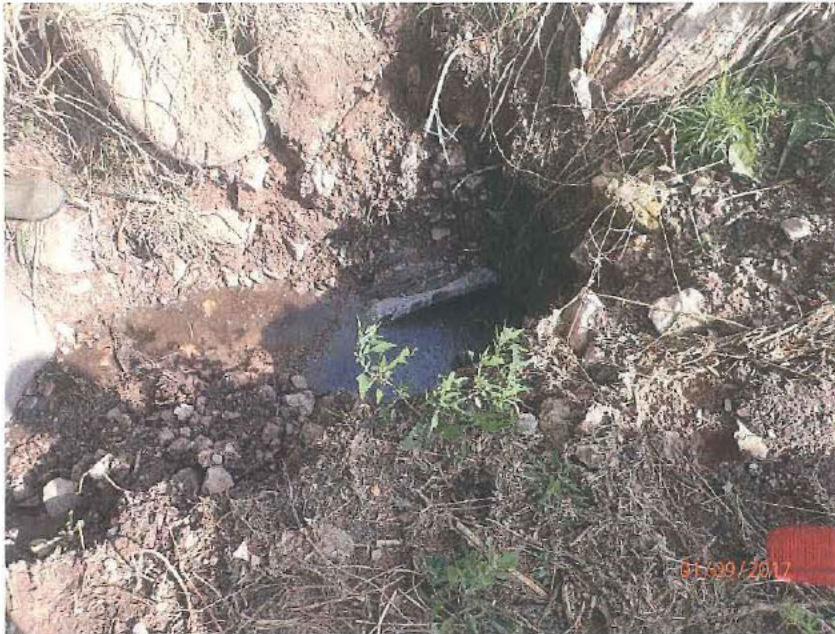
21: P9012529

The largest/tallest pipe directed any process wastewater that reached its level directly to the ditch on the west side of the facility as a bypass. The pipe was calculated to only take flow that exceeded the amount of a 25-year/24-hour storm and a 35 foot buffer was retained in the ditch below the outlet of this pipe. EPA observed the outlet of this pipe and noticed that the water beneath the pipe was darkly colored.

Description: Outlet for the bypass pipe in the ditch on the west side of the facility. Water beneath pipe was dark colored and appeared to have nutrients in it.

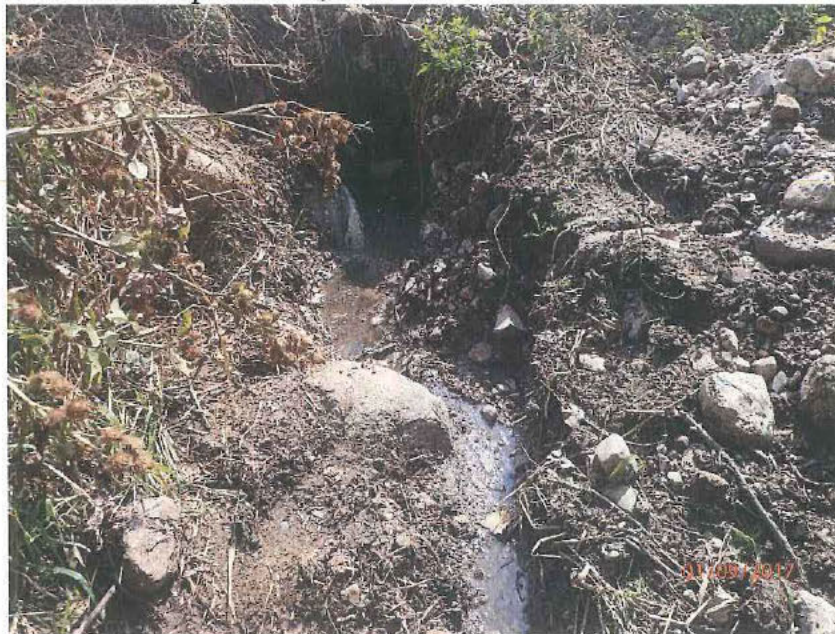
22: P9012530

Description: Channel from the outlet of the bypass pipe. Flow goes to the unnamed perennial stream.

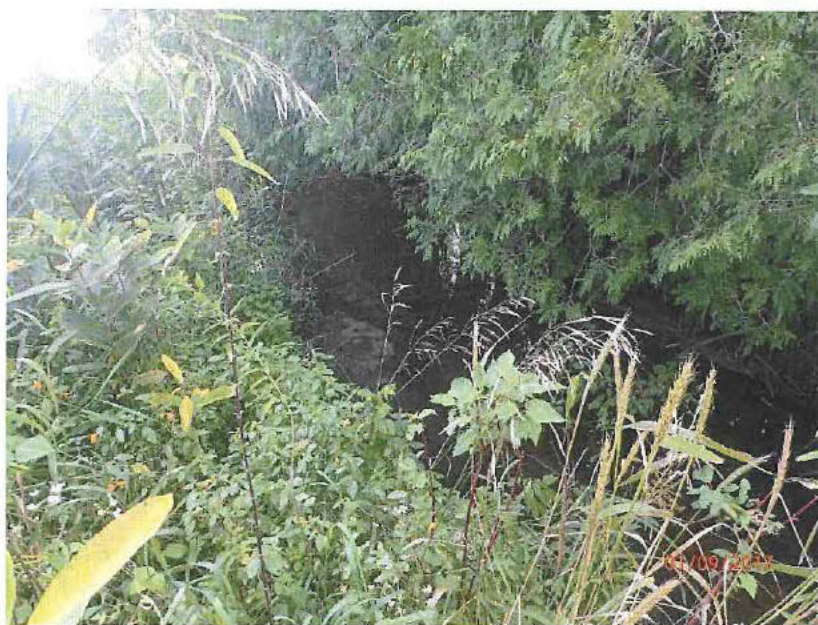
35: P9012543

EPA then walked to the unnamed perennial stream and noticed that the water appeared to be clear and free of bottom solids.

Description: The unnamed perennial stream had water in it and it appeared clear.

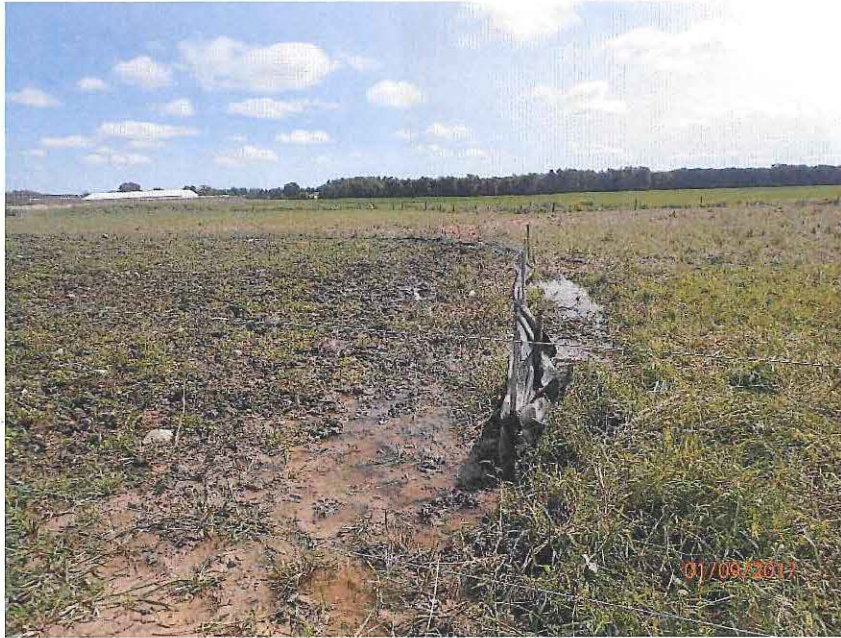
38: P9012546

Description: Cattle are allowed out into Pasture #2. The fencing for Pasture #2 has been moved north so the cattle don't have access to the southern portion.

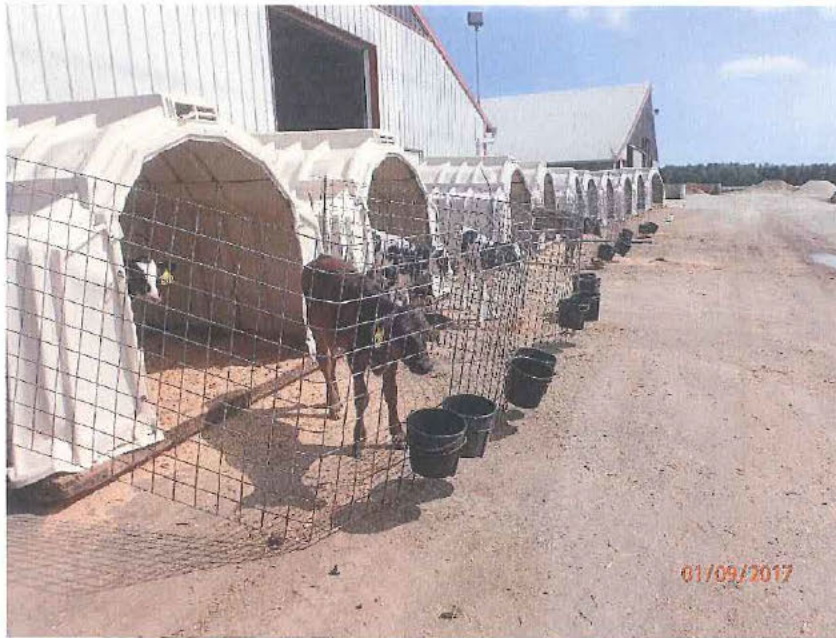
48: P9012556

EPA also observed the superhutches and Calf Hutch Pad had no containment for manure or process wastewater. All the manure and process wastewater from these three areas would flow to the south to Pasture #2. Heavy precipitation could carry these pollutants to the unnamed perennial stream. The transport of the process wastewater through Pasture #2 would also be aided by the flow out of a storm water pipe that discharges storm water from the north side of the facility to the north end of Pasture #2.

Description: Superhutches on the south side of the Freestall barns.

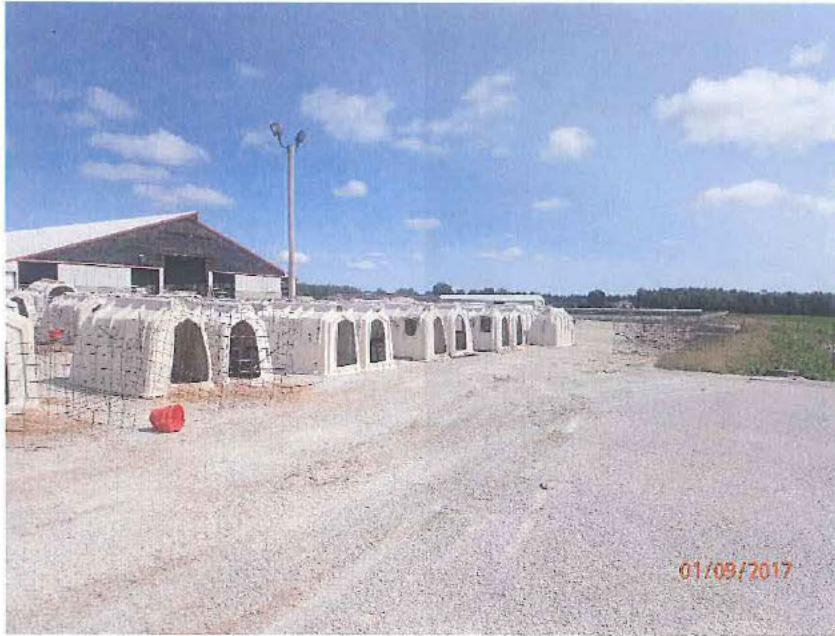
52: P9012560

Description: Manure and process wastewater from the calf hutches would flow to the south and into Pasture #2.

Location: Southwest corner of Calf Hutch Pad.

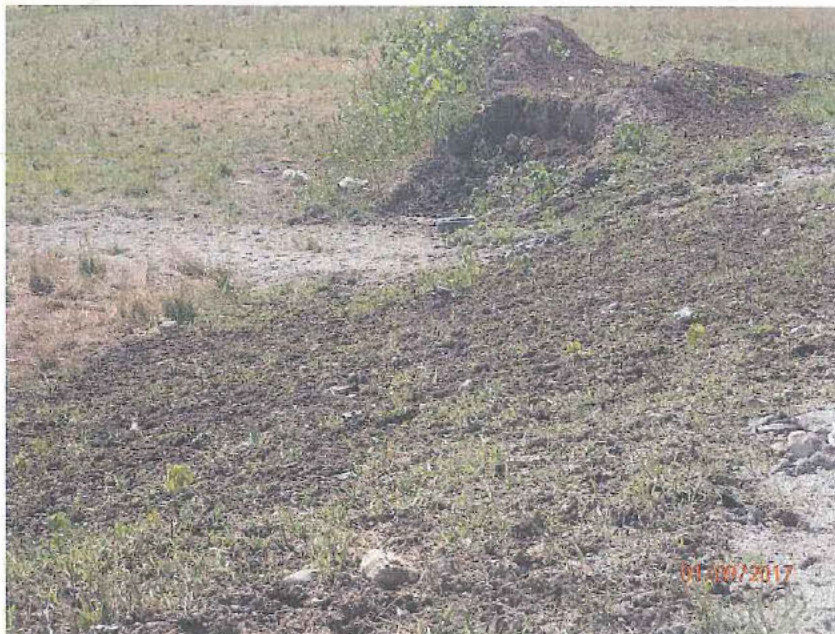
53: P9012561

Description: Clean out riser pipe for the manure transfer line is located in Pasture #2.

Location: North of Pasture #2.

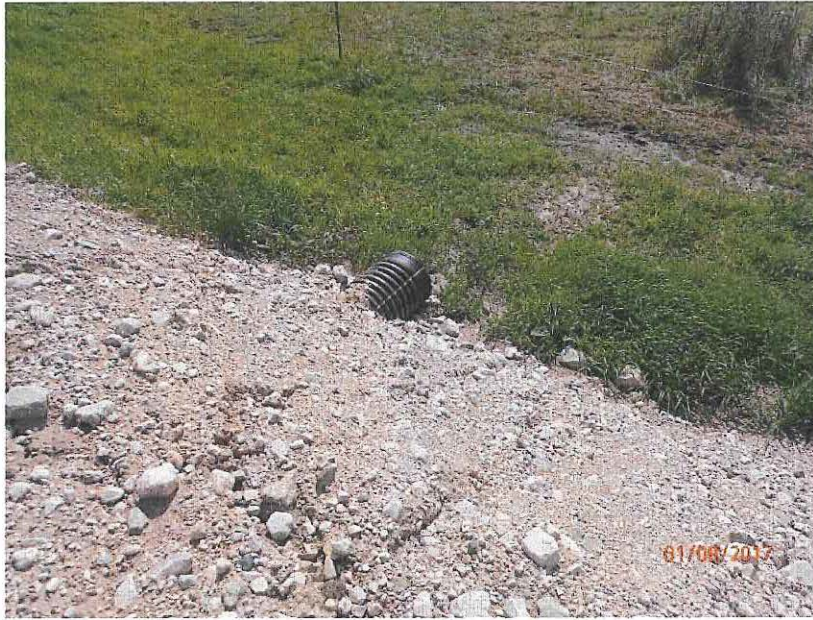
54: P9012562

Description: Storm water pipe under facility driveway outlets at the top of Pasture #2.

Location: North of Pasture #2.

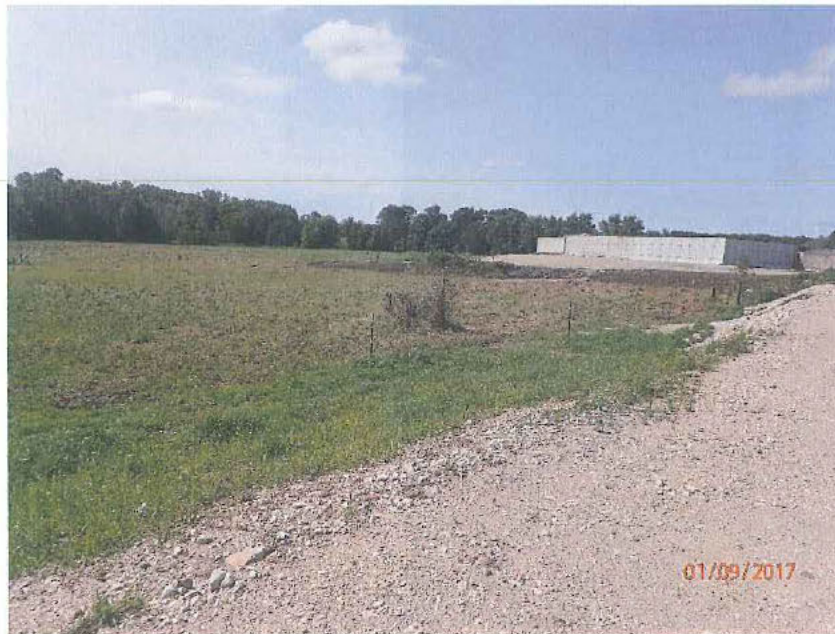
57: P9012565

Description: A pipe inlet inside the fencing collects storm water and outlets to the ditch on the east side of the facility.

Location: East of Pasture #2.

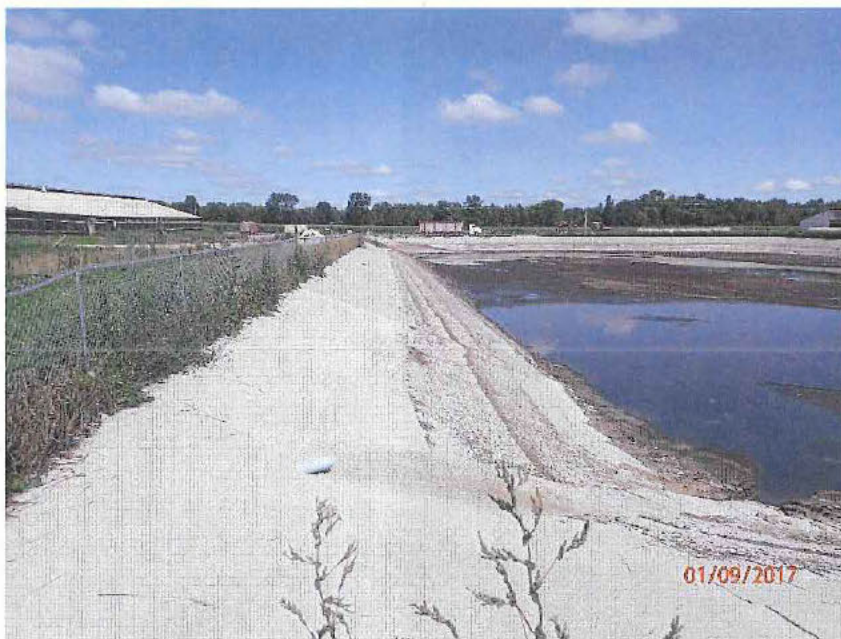
58: P9012566

Waste Storage Pond #2 was built in 2015 and holds 10.8 million gallons. It receives manure and process wastewater from Waste Storage Pond #1 via a weir cut into the berm between them. It also receives process wastewater from the Feed Storage Pad via the pump in the collection tank. It has a ramp and a Solids Stacking Pad at the northwest corner. The pond is lined with concrete and has PVC markers along the ramp to indicate the depth of the manure in the pond, although none of the markers have the Maximum Operating Level (MOL) identified.

Description: Waste Storage Pond #2 was built in 2015 and has storage capacity for 10.8 million gallons. Green pipe is for process wastewater from the tank south of the Feed Storage Pad.

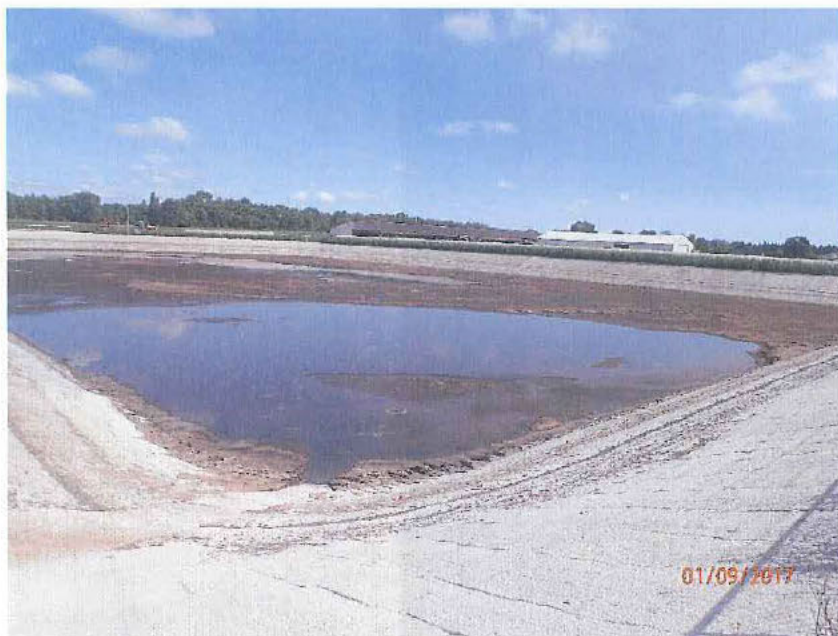
59: P9012567

Description: Waste Storage Pond #2 is lined with concrete.

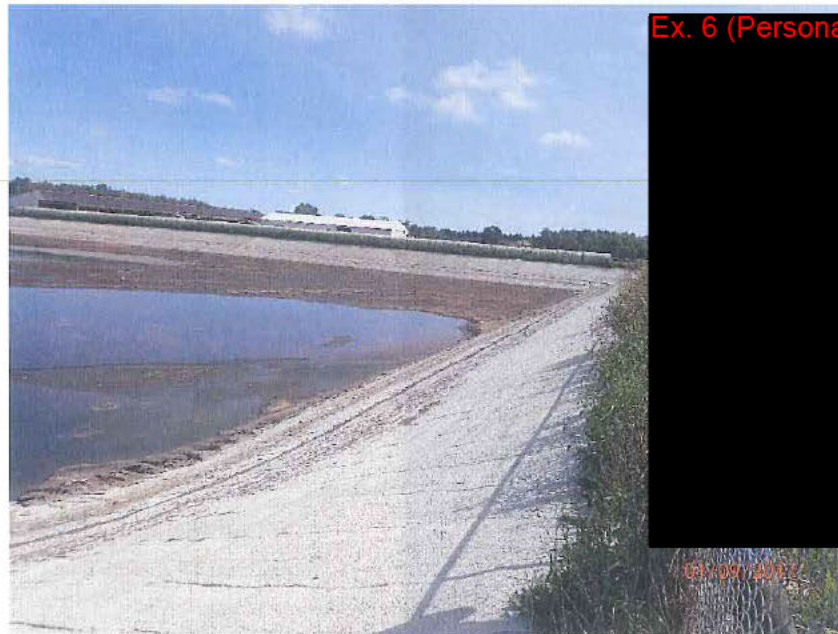
60: P9012568

Description: Green pipe in southeast corner of pond was installed to allow for potential to take water from the pond and use to flush the barns.

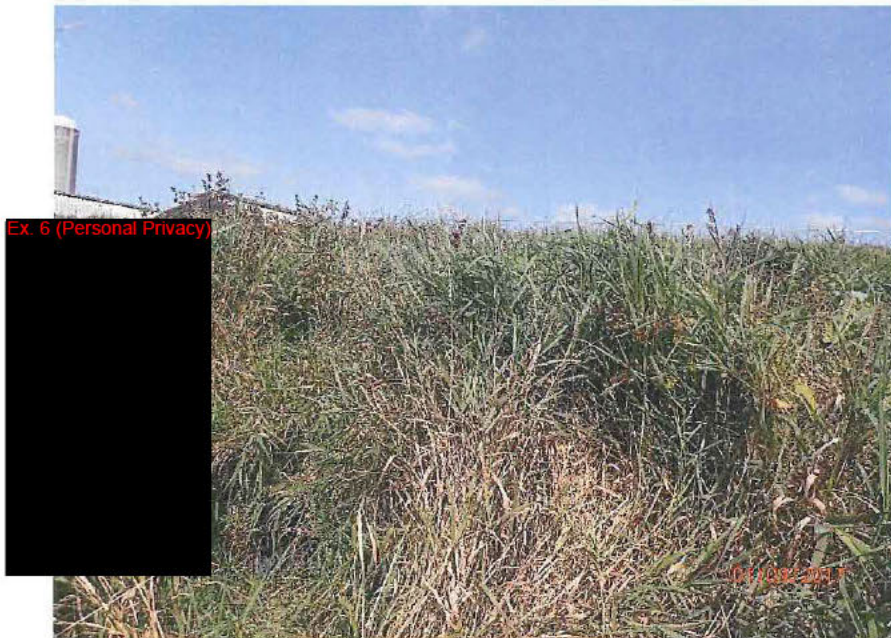
61: P9012569

On the day of the inspection, the Waste Storage Pond #2 had approximately 14 feet of freeboard. A ditch on the east side of the facility had been tiled and relocated so that it went south along the east side of the pond and outletted at the north end of Pasture #3. EPA observed this outlet and the minimal amount of liquid beneath it appeared to be clear.

Description: The ditch on the east side of the facility has been piped underground and around the east side of Waste Storage Pond #2. It outlets south of Waste Storage Pond #2.

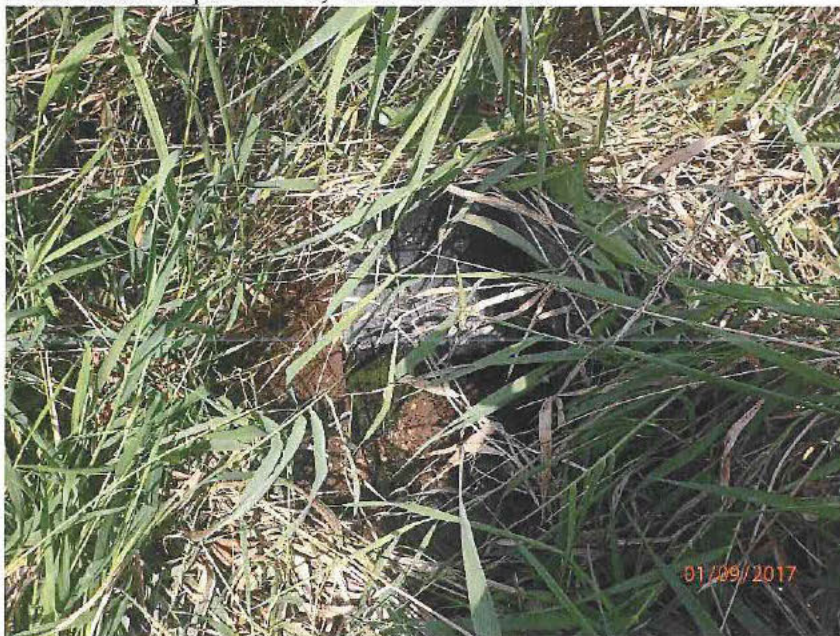
62: P9012570

Description: Outlet of storm water pipe south of Waste Storage Pond #2. In the summer, some plate cooler water may also be discharged through this pipe.

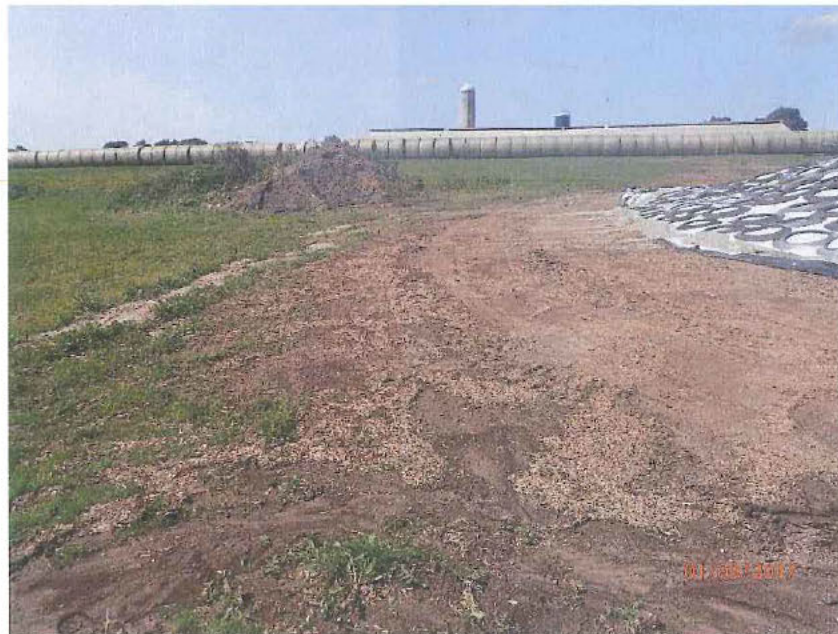
68: P9012576

EPA then walked east to the Calf Barn and observed the silage pile that was stored on the ground to the south of the barn. The silage was tarped and only had a minimal amount of feed around the pile. Process wastewater from the silage would flow to the south to a crop field. The land in this area was flatter and EPA did not observe any flow pathways in the field that would indicate that the process wastewater from the silage would reach all the way to the south to the unnamed perennial stream.

Description: Precipitation can transport silage to the south to a crop field.

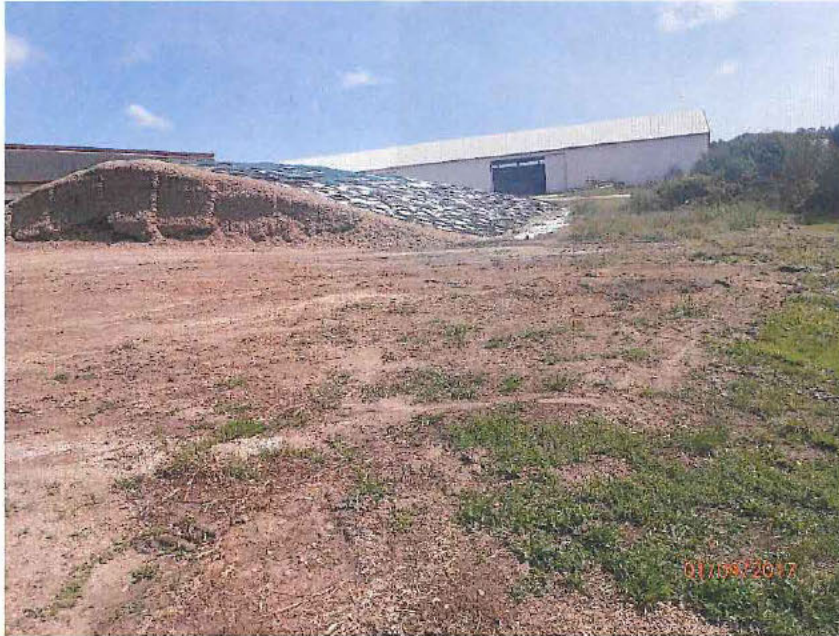
69: P9012577

Description: The owner stated that this silage pile should be fed out by November 2017 and silage wouldn't need to be stored there anymore.

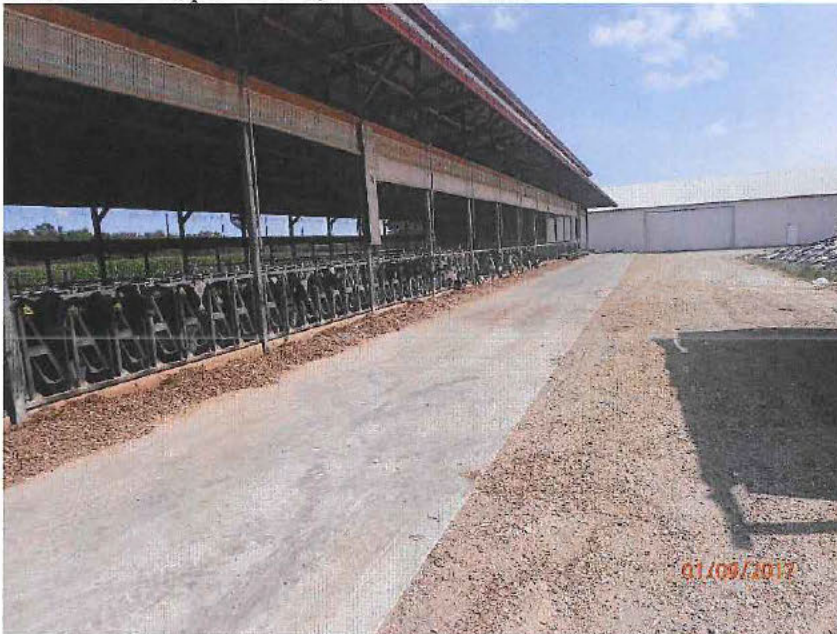
70: P9012578

Description: Roof overhang would keep precipitation from transporting feed from the feed lane of the Calf Barn.

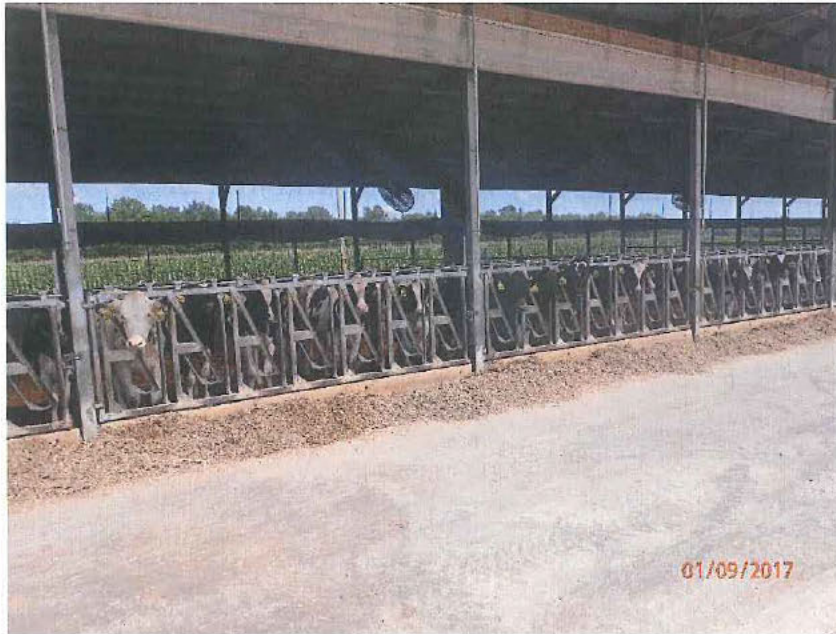
71: P9012579

Description: Feed is kept pushed back to stay close to the cattle and under the roof overhang.

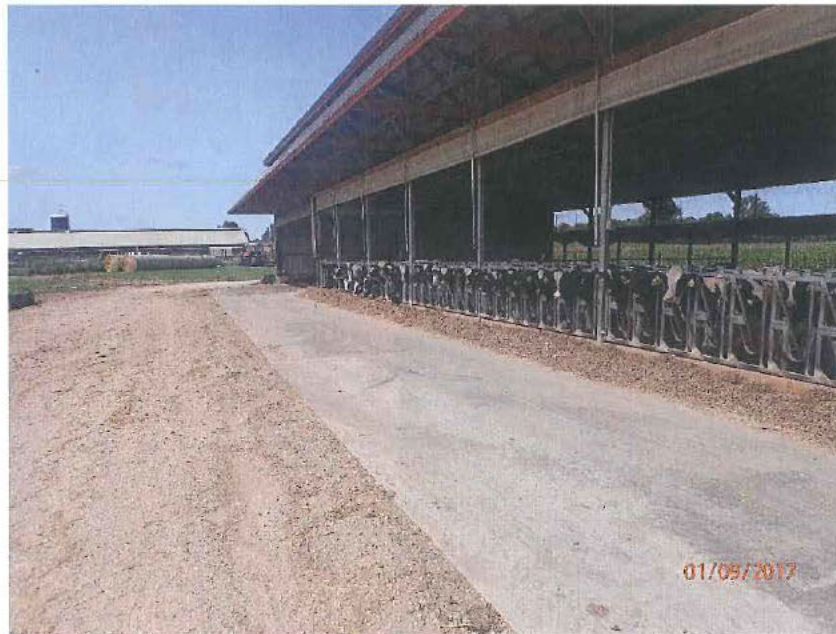
72: P9012580

Description: Feed is kept pushed back to stay close to the cattle and under the roof overhang.

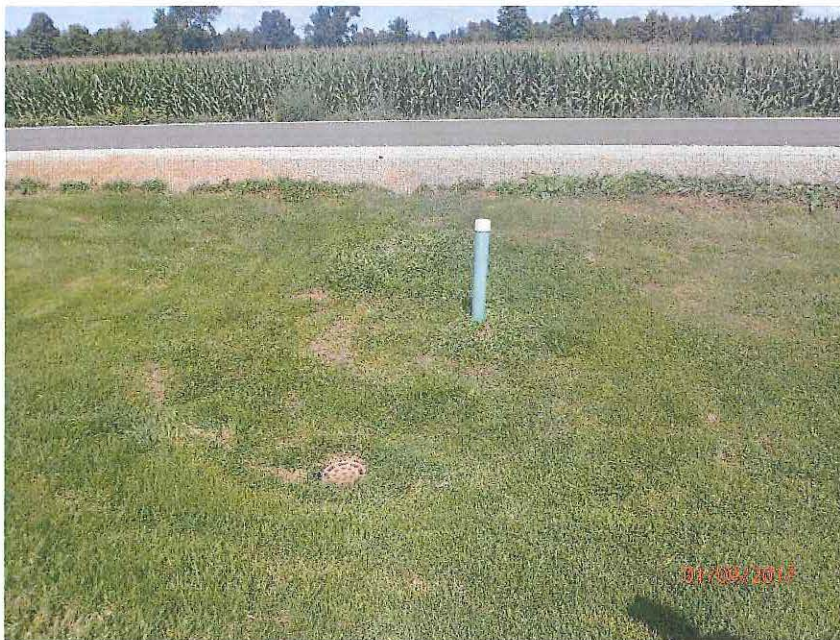
77: P9012585

Description: Tile inlet for storm water pipe that outlets south of Waste Storage Pond #2.

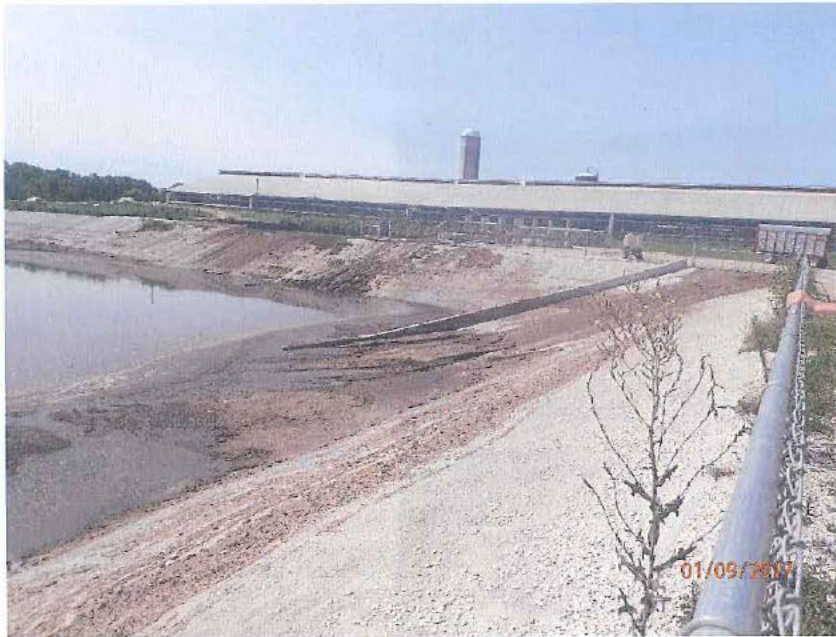
79: P9012587

Description: Depth markers are installed in the concrete wall into the pond.

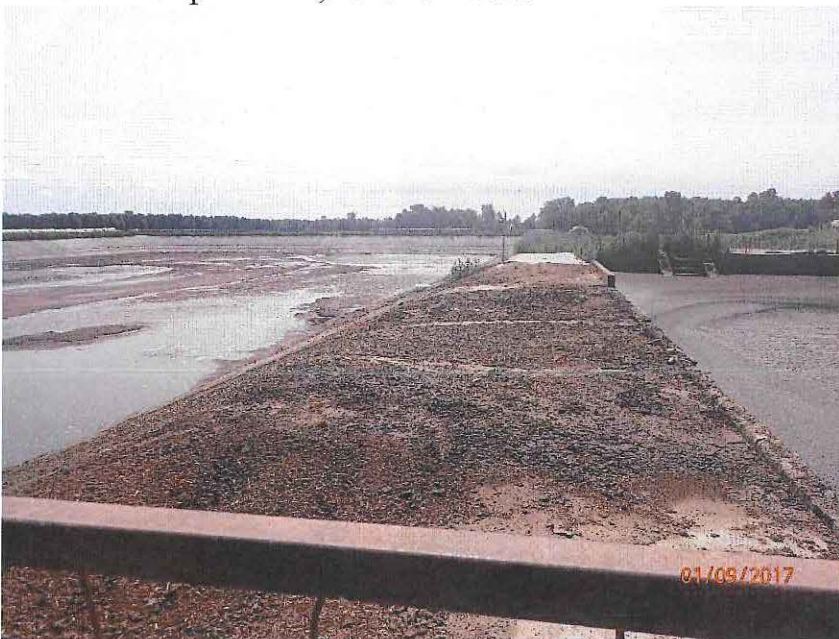
86: P9012594

Description: Manure can flow over the top of the berm between Waste Storage Pond #1 and #2. A valve can also be opened and allow manure to flow from Waste Storage Pond #1 to #2 through the white pipe in the berm.

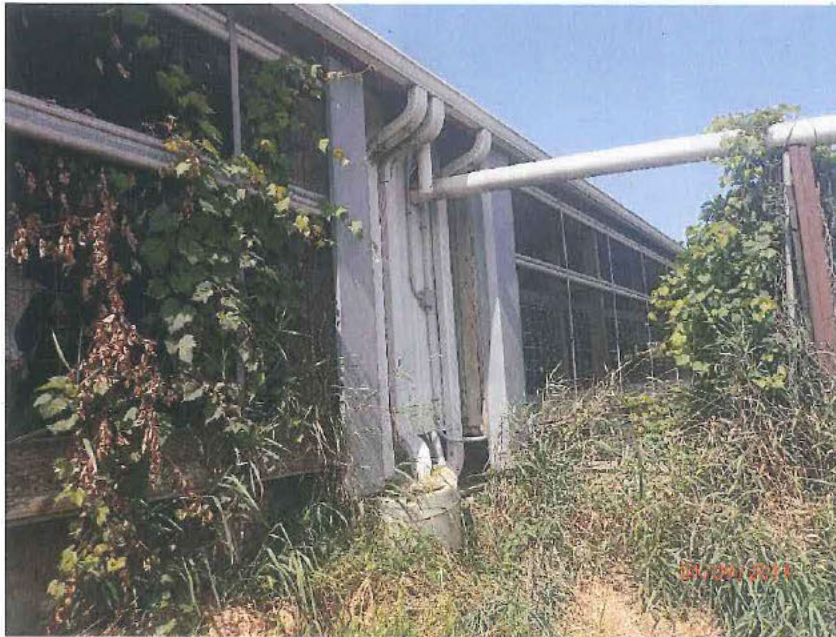
87: P9012595

EPA then walked south along the east side of Freestall Barn #1 and observed that the barn had rain gutters which were tied into downspouts and piping which outlet in Pasture #2. EPA walked north through the center alley of Freestall Barn #1 and noted that the facility stored new sand in a small bunker on the north side of the barn. Manure in the barn is scraped to the center and into the manure channel which flows, with the help of an auger, to Waste Storage Pond #1.

Description: Gutters on Freestall Barn #1 are tied into underground piping which discharges in Pasture #2.

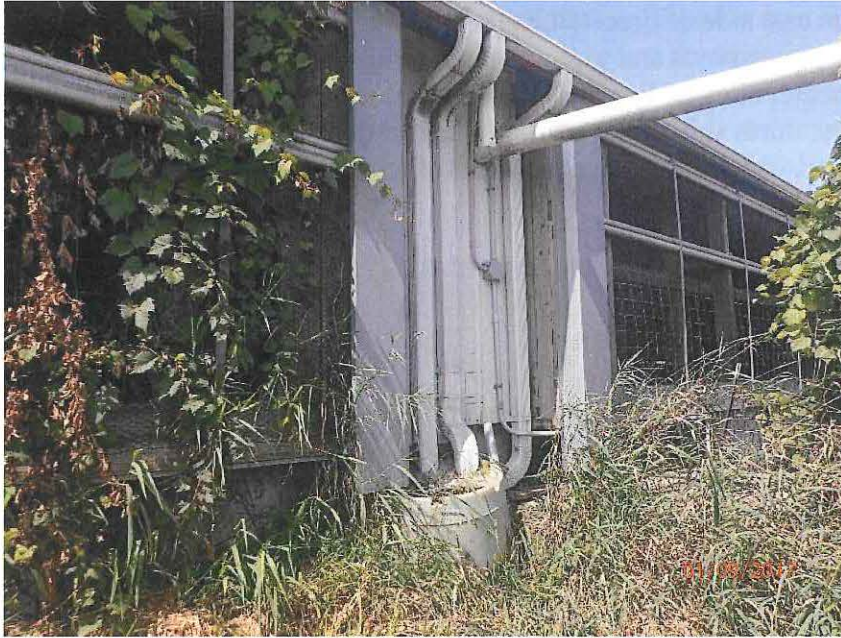
88: P9012596

Description: Gutters on Freestall Barn #1 are tied into underground piping which discharges in Pasture #2.

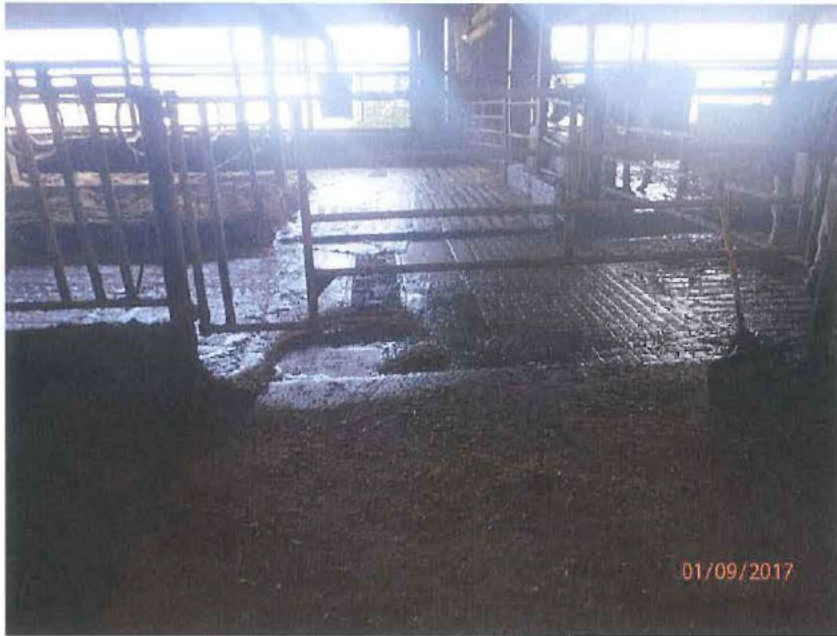
90: P9012598

Description: Manure is scraped to center of barn and to a manure channel. The manure flows to Waste Storage Pond #1 via gravity and with the assistance of an auger.

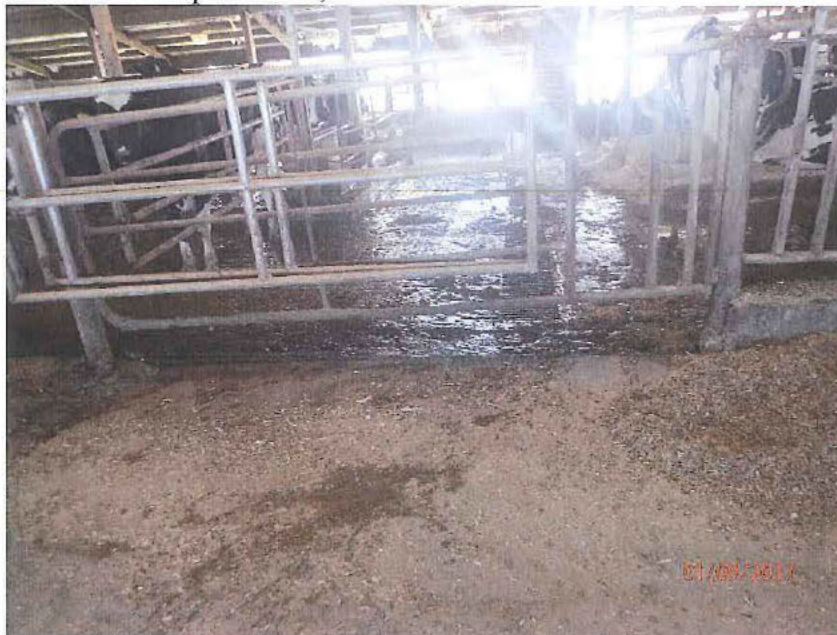
91: P9012599

Description: Manure is scraped to center of barn and to a manure channel. The manure flows to Waste Storage Pond #1 via gravity and with the assistance of an auger.
